SERVICE INFORMATION

ST-010-06

SUBJECT: Defrost Control 031-01975-000 (S1-03101975000) SAP#10211

UNITS: B*HP042A06, B*HZ042A06

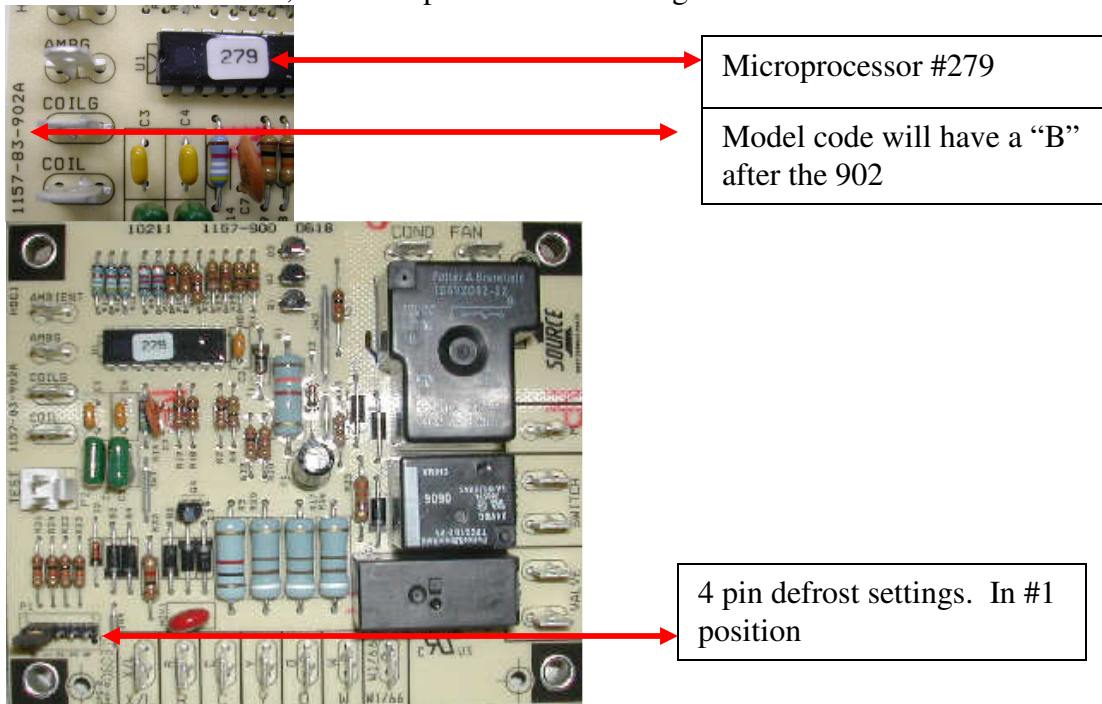
The New version of the S1-03101975000 board with the revised service Pin #4 is designated as a "B" version. Unfortunately the vendor failed to change the code to a "B" on the first shipment of new boards. However, the microprocessor was changed and will have a #279 label.
