SERVICE INFORMATION

YS-078-06

SUBJECT: FC9C Modulating Furnaces With ECM Motor Control Board
S1-03109153000

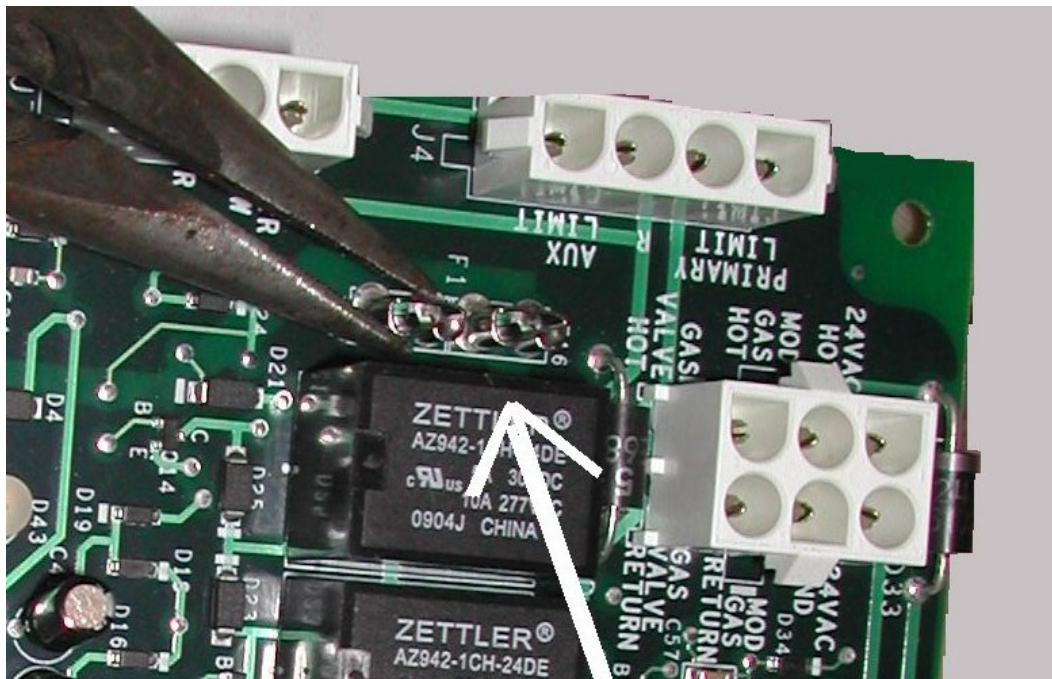
Some boards for the ECM modulating furnace may contain the incorrect fuse socket terminals. Because of shipping, handling or furnace vibration, the fuse socket may allow the fuse to become loose resulting in an Error Code 4, Open Limit or Open Onboard 24 VAC fuse. Note: The LED fault light is powered by 120 VAC on this board.

Slightly Crimping Fuse Holder Sockets With Pliers For Tight Fit

Please instruct the installing contractors to tighten the fuse terminal socket when installing the furnace on new installations.
